# Case Study

## Manway Chamber

MoD Site, Borden

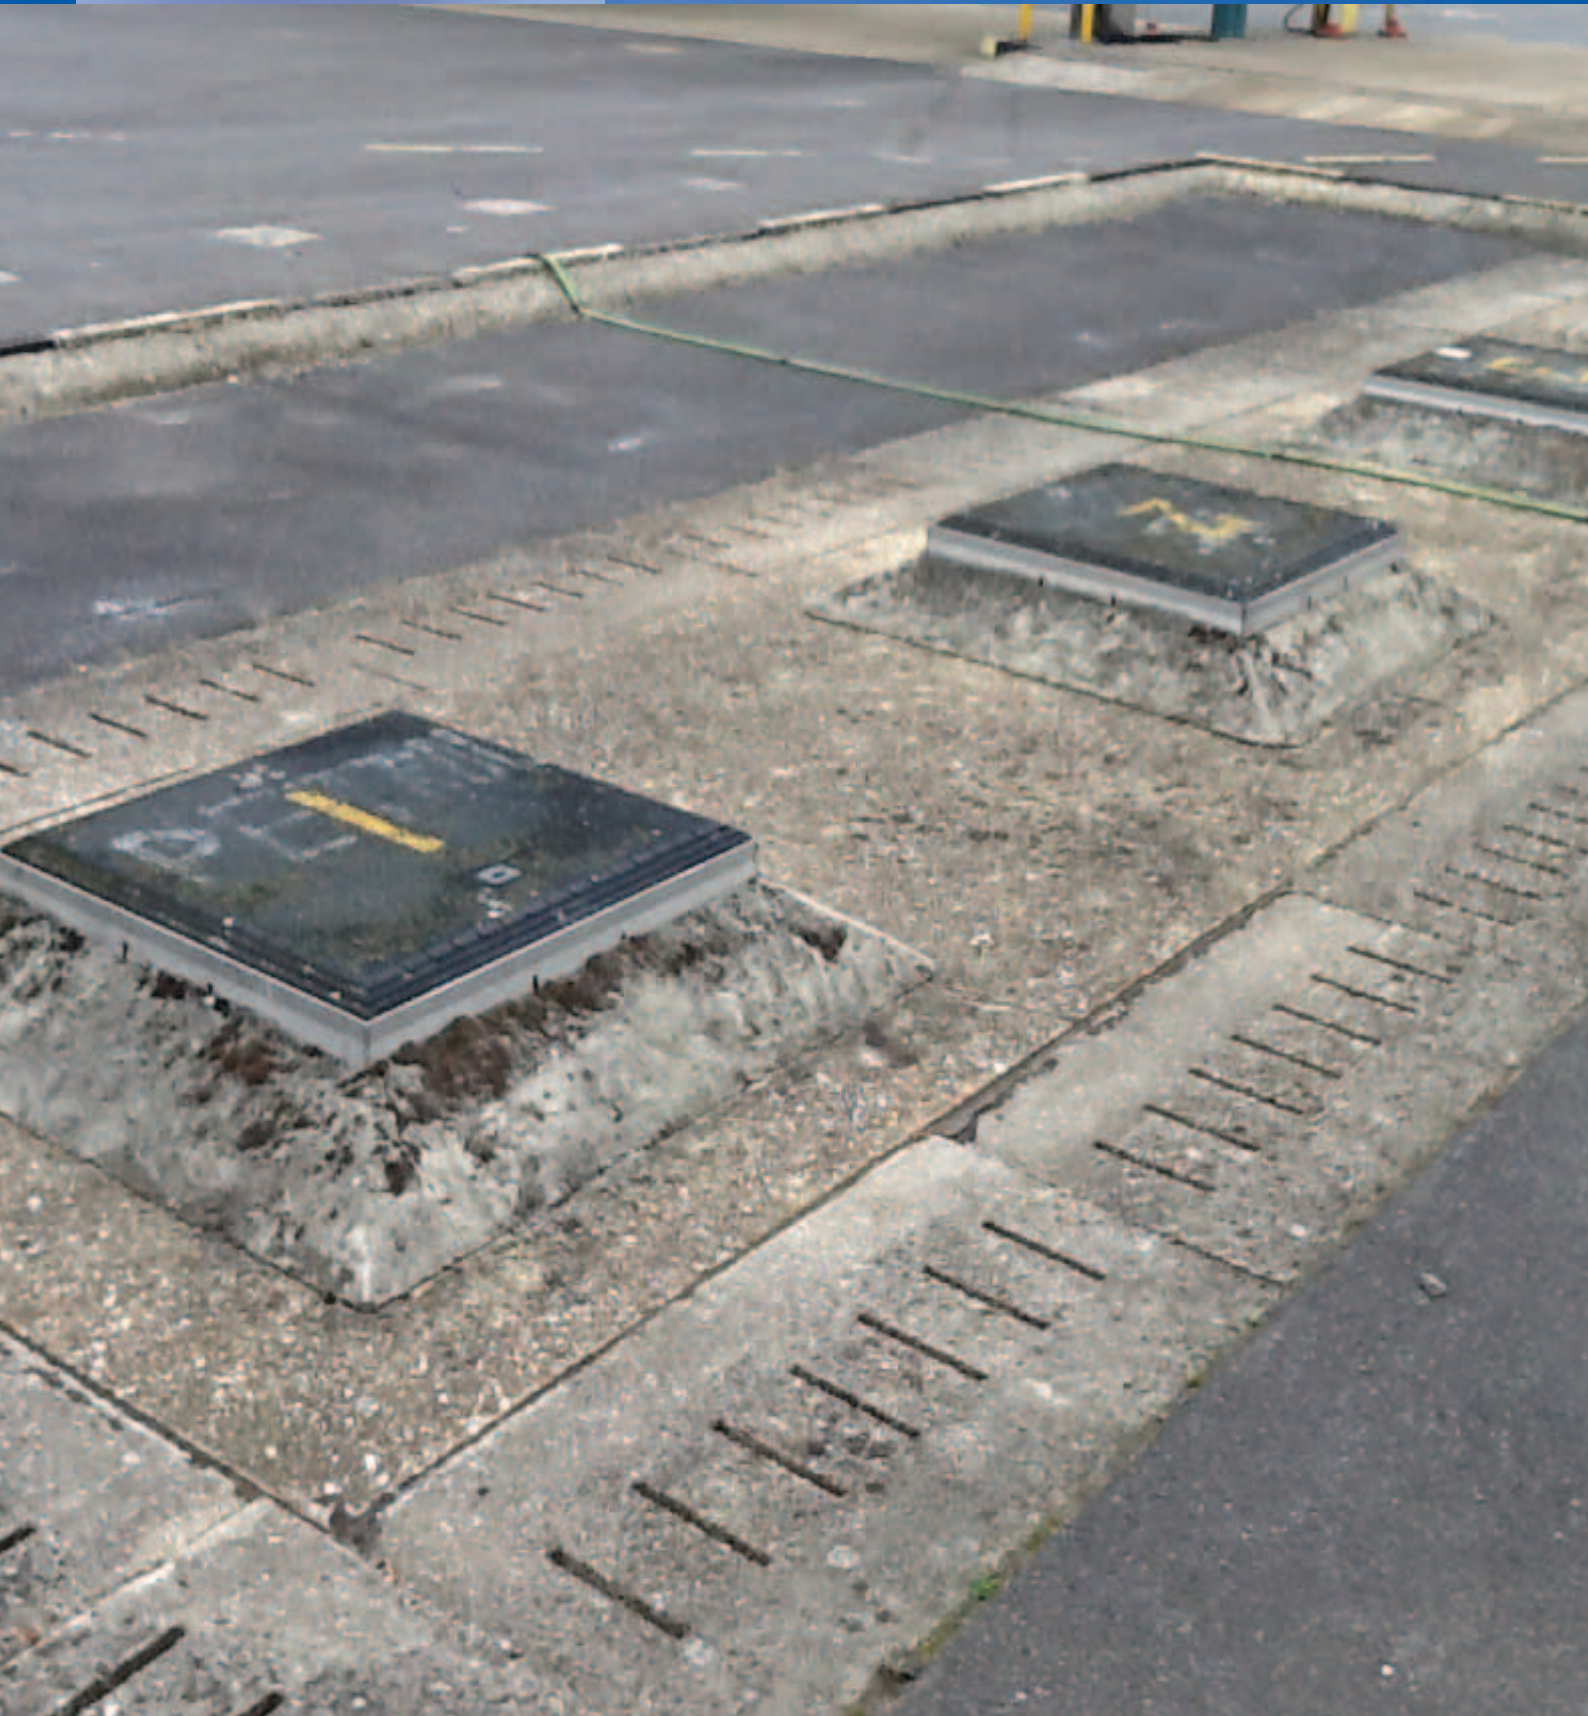
A Ministry of Defence (MoD) site on a garage forecourt had fuel manway lids leading to four fuel tanks surrounded by concrete.

With time and high water table, the tanks move up and down, causing damage to the seals between the top of the tank and the manway chamber which could lead to water ingress.

Glass Reinforced Plastic (GRP) walls were fixed to poor quality substrate and sealed with soft joints from the base of the walls to the top of the fuel tank. Adalline 400 multi-spray system was used on four GRP walls and 100mm was sprayed onto the tank lid to make a permanent seal which would stop water ingress to the manway lid chamber. Adalline 400 multi spray can withstand 11 bar of negative pressure.

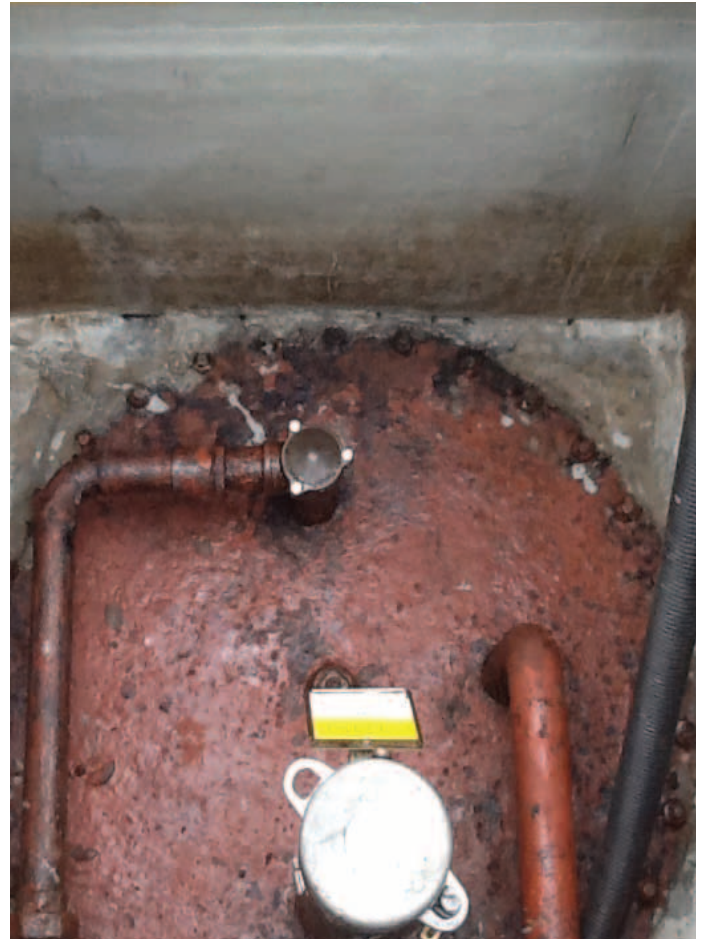
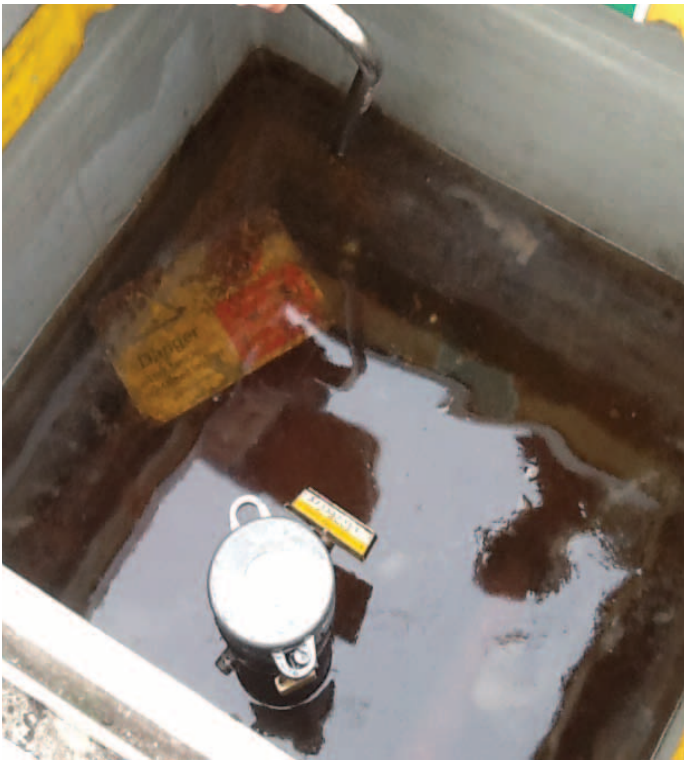
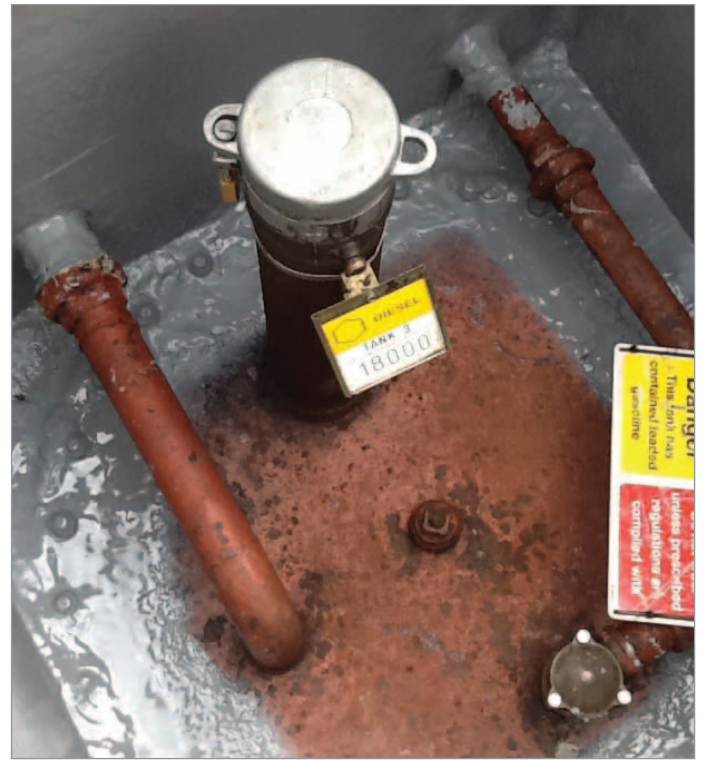
The works were completed in August 2014 and the manway chambers are dry, albeit for some condensation on the upper side of the manway lids.
