# Case Study Pipe Protection Telecommunications, London

## The Project

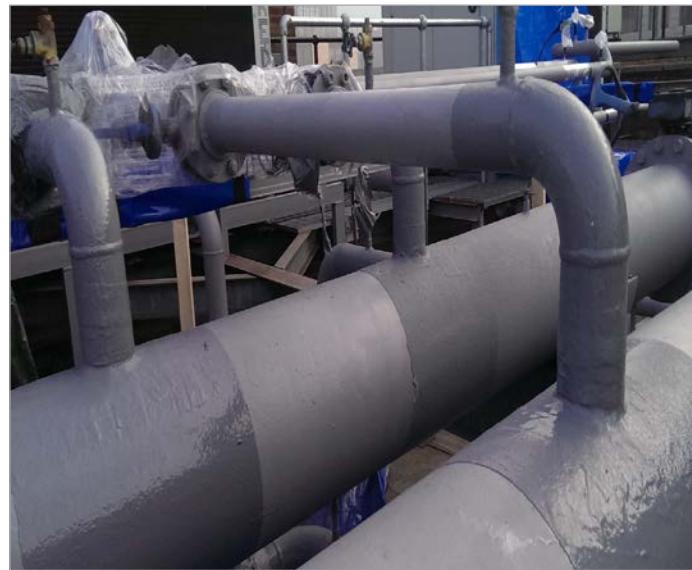
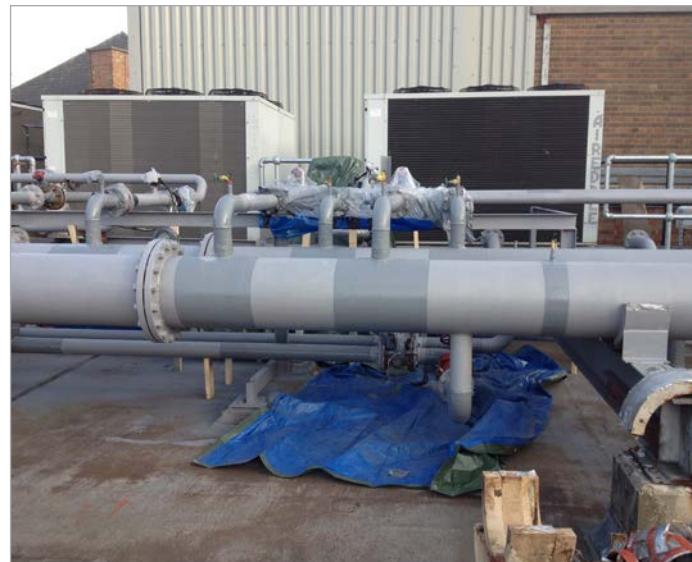
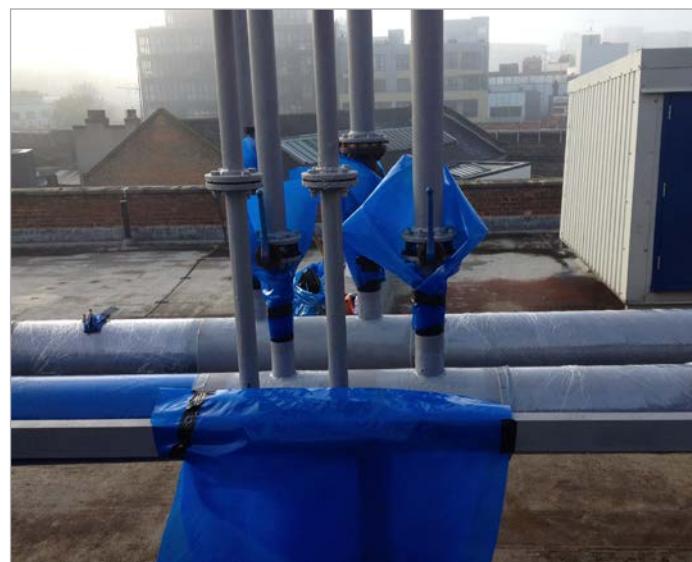
We carried out remedial work and found the corrosion to be most severe around the pipe joints and valves. There was also evidence of some weeping that highlighted the need for urgent action. Adler and Allan were the only contractor able to offer a long term solution without comprising network integrity.

All the surfaces were cleaned and with only minimal preparation so as not to further damage the corroded pipes. A very tolerant zinc epoxy coating was then applied to all of the piping. This coating was chosen as it was especially developed for coating electricity pylons, even in the rain. This allowed Adler and Allan to complete the repair whilst the centre was still live and in full operational use.

The joints were then treated with a super-strong, glass flake epoxy system with a reinforcing glass fibre matt layered into it to create a wrapping bandage. Even if the metal pipework completely dissolves underneath, the remaining protective 'shell' will continue to carry the pipe coolant so as not to interrupt service.

Finally, an impact resistant, high strength polyurea seal was sprayed around the main junction repairs to increase the strength and protection of the whole system. This unique technology coating system has the unusual properties of being both very strong, as well as remaining flexible under load.
