# Case Study Pipework Recoating

Gas Power Station,  
Nottinghamshire

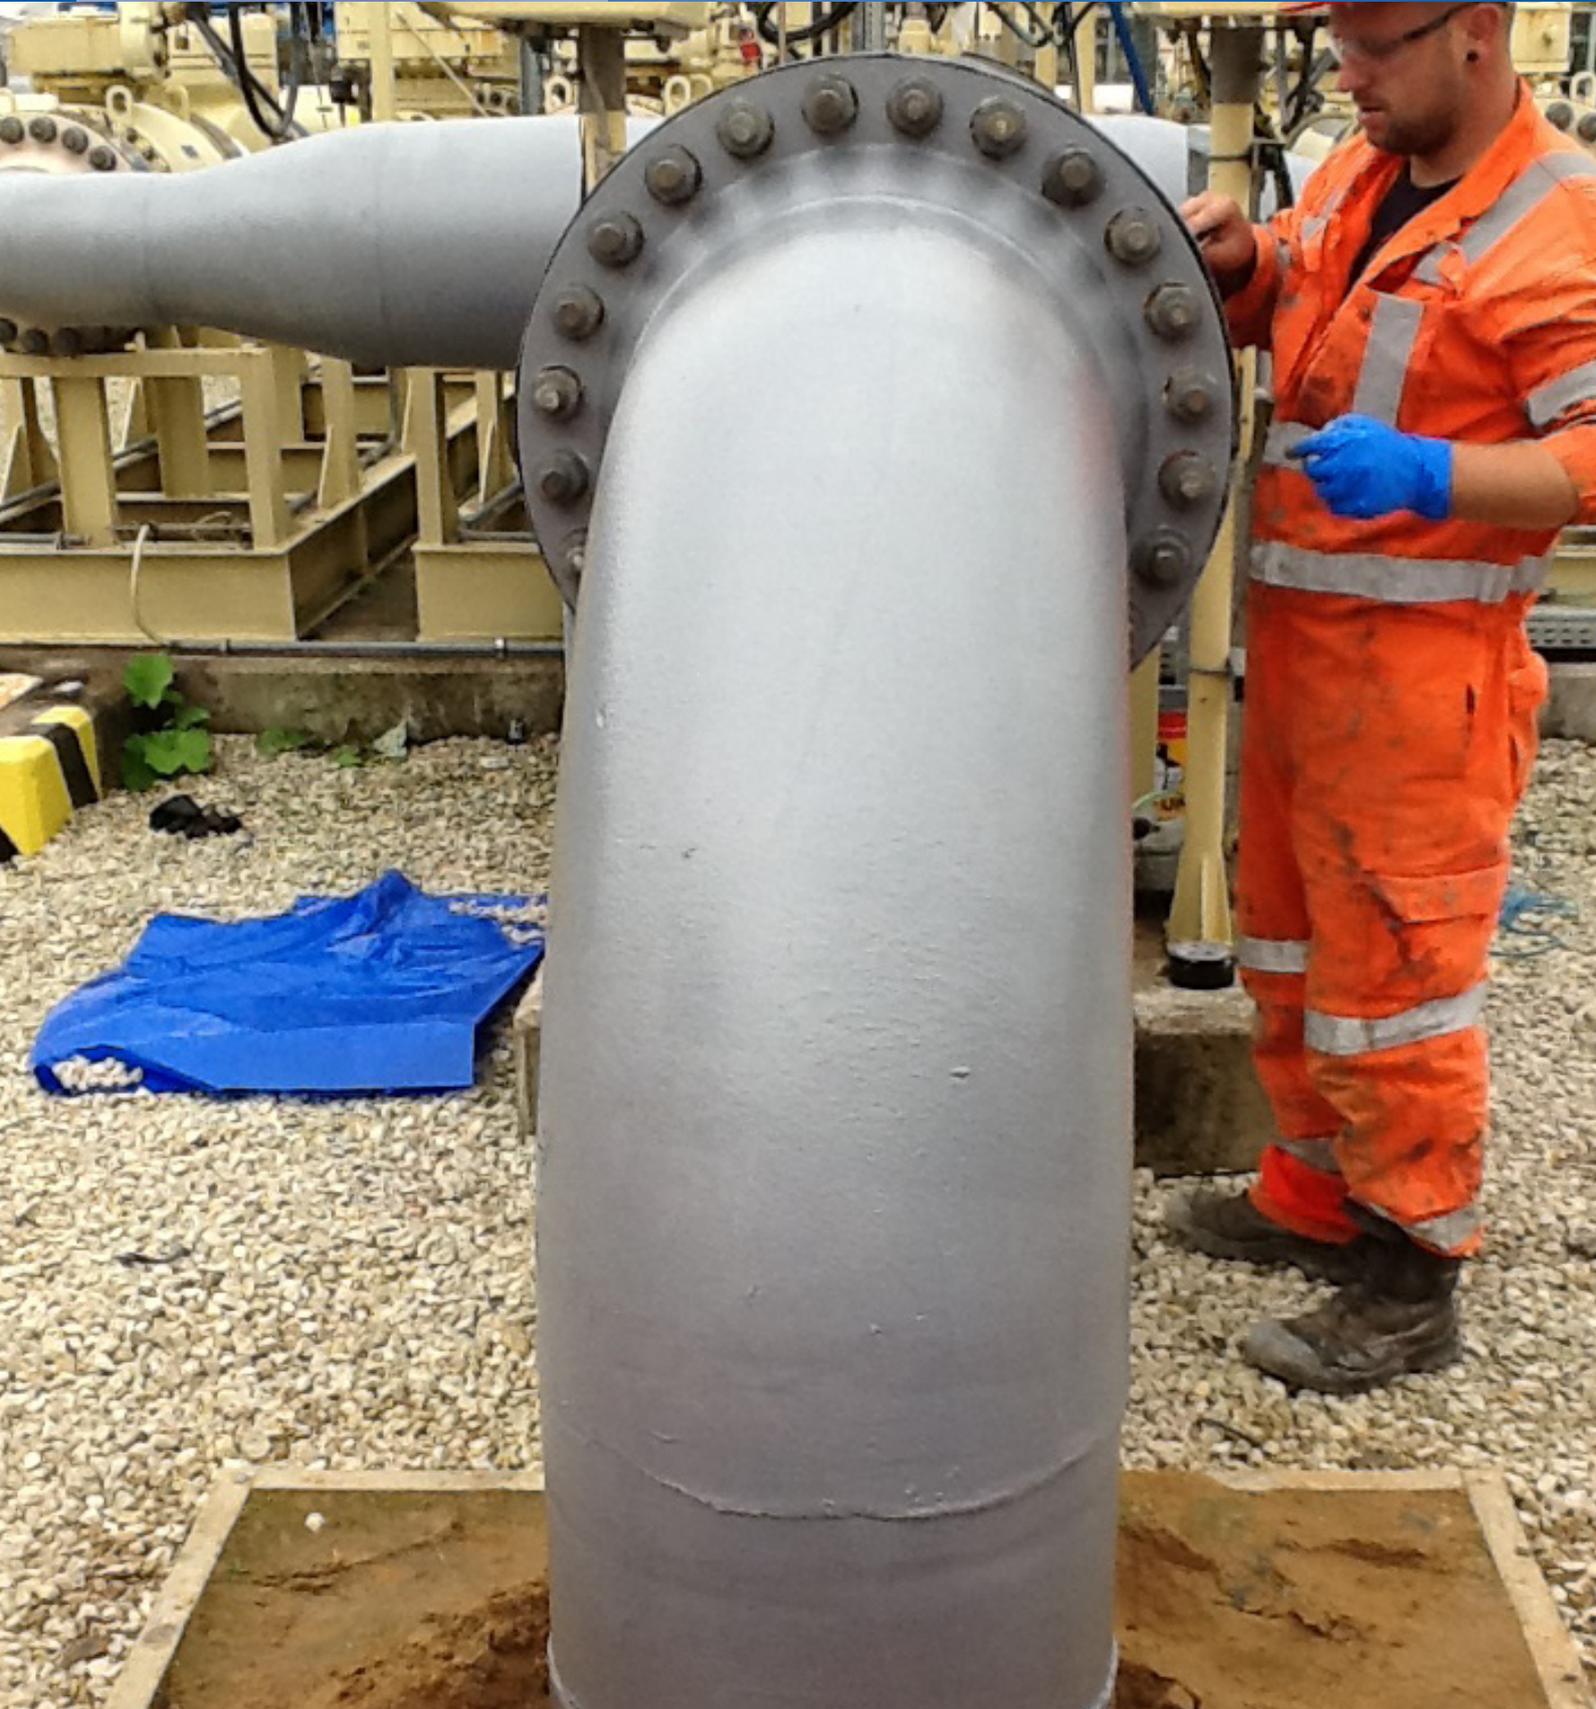
At a gas-fired power station in West Burton, Nottinghamshire, the client had identified signs of surface corrosion on the gas pipe infrastructure.

Our assessment identified the best commercial solution was to re-coat as this could be co-ordinated with a planned shut down. The affected area of pipework required minor remedial works to secure lasting adhesion of the new coating. All leading edges were 'feathered back' with abrasive sanding methods, removing all sharp edges to ensure a smooth transition from the intact coating to the substrate. Intact coating around the damaged areas was abraded for a minimum 50mm to impart a surface profile, and surrounding coating was de-glossed. To ensure the surface was clean, dry and free from any contamination, the entire area was power washed and airline dried.

Adler & Allan teams then applied a specialist coat of Jotamastic 90, a two component polyamine cured epoxy mastic coating, which is surface tolerant and abrasion resistant, providing a long-lasting protection ideal for power plant environments. The new coating was finished off with two applications of acrylic polyurethane coating, giving the pipework a long lasting, resistant and durable finish.

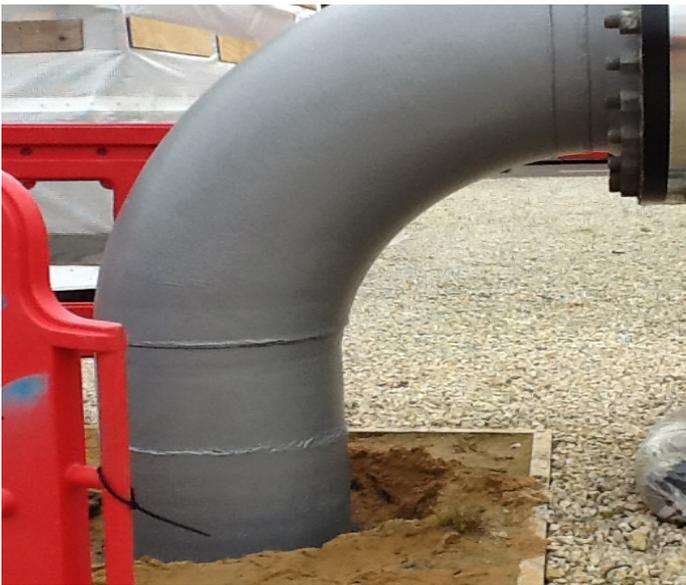
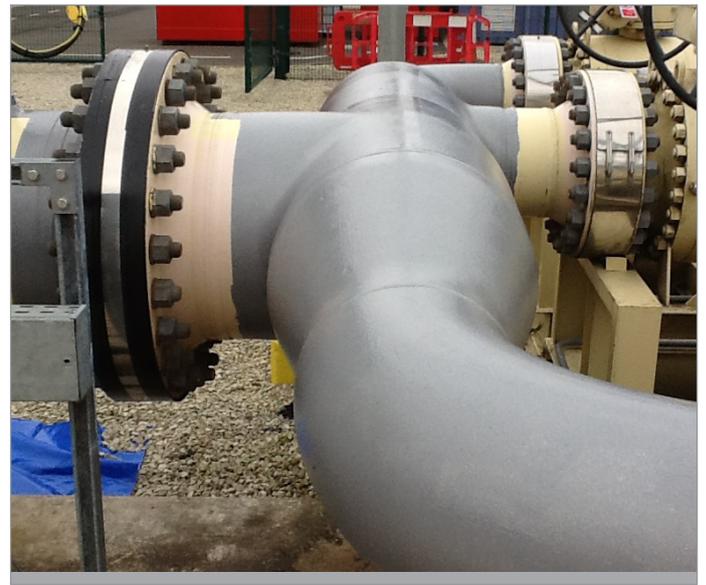
The project was delivered on time and the new coating has elongated the expected life of the treated areas by up to 10 years, exceeding the customer's expectations.
