Case Study Roof Lining

BT Blackley, Manchester

Adalline® 400 Coating Solution

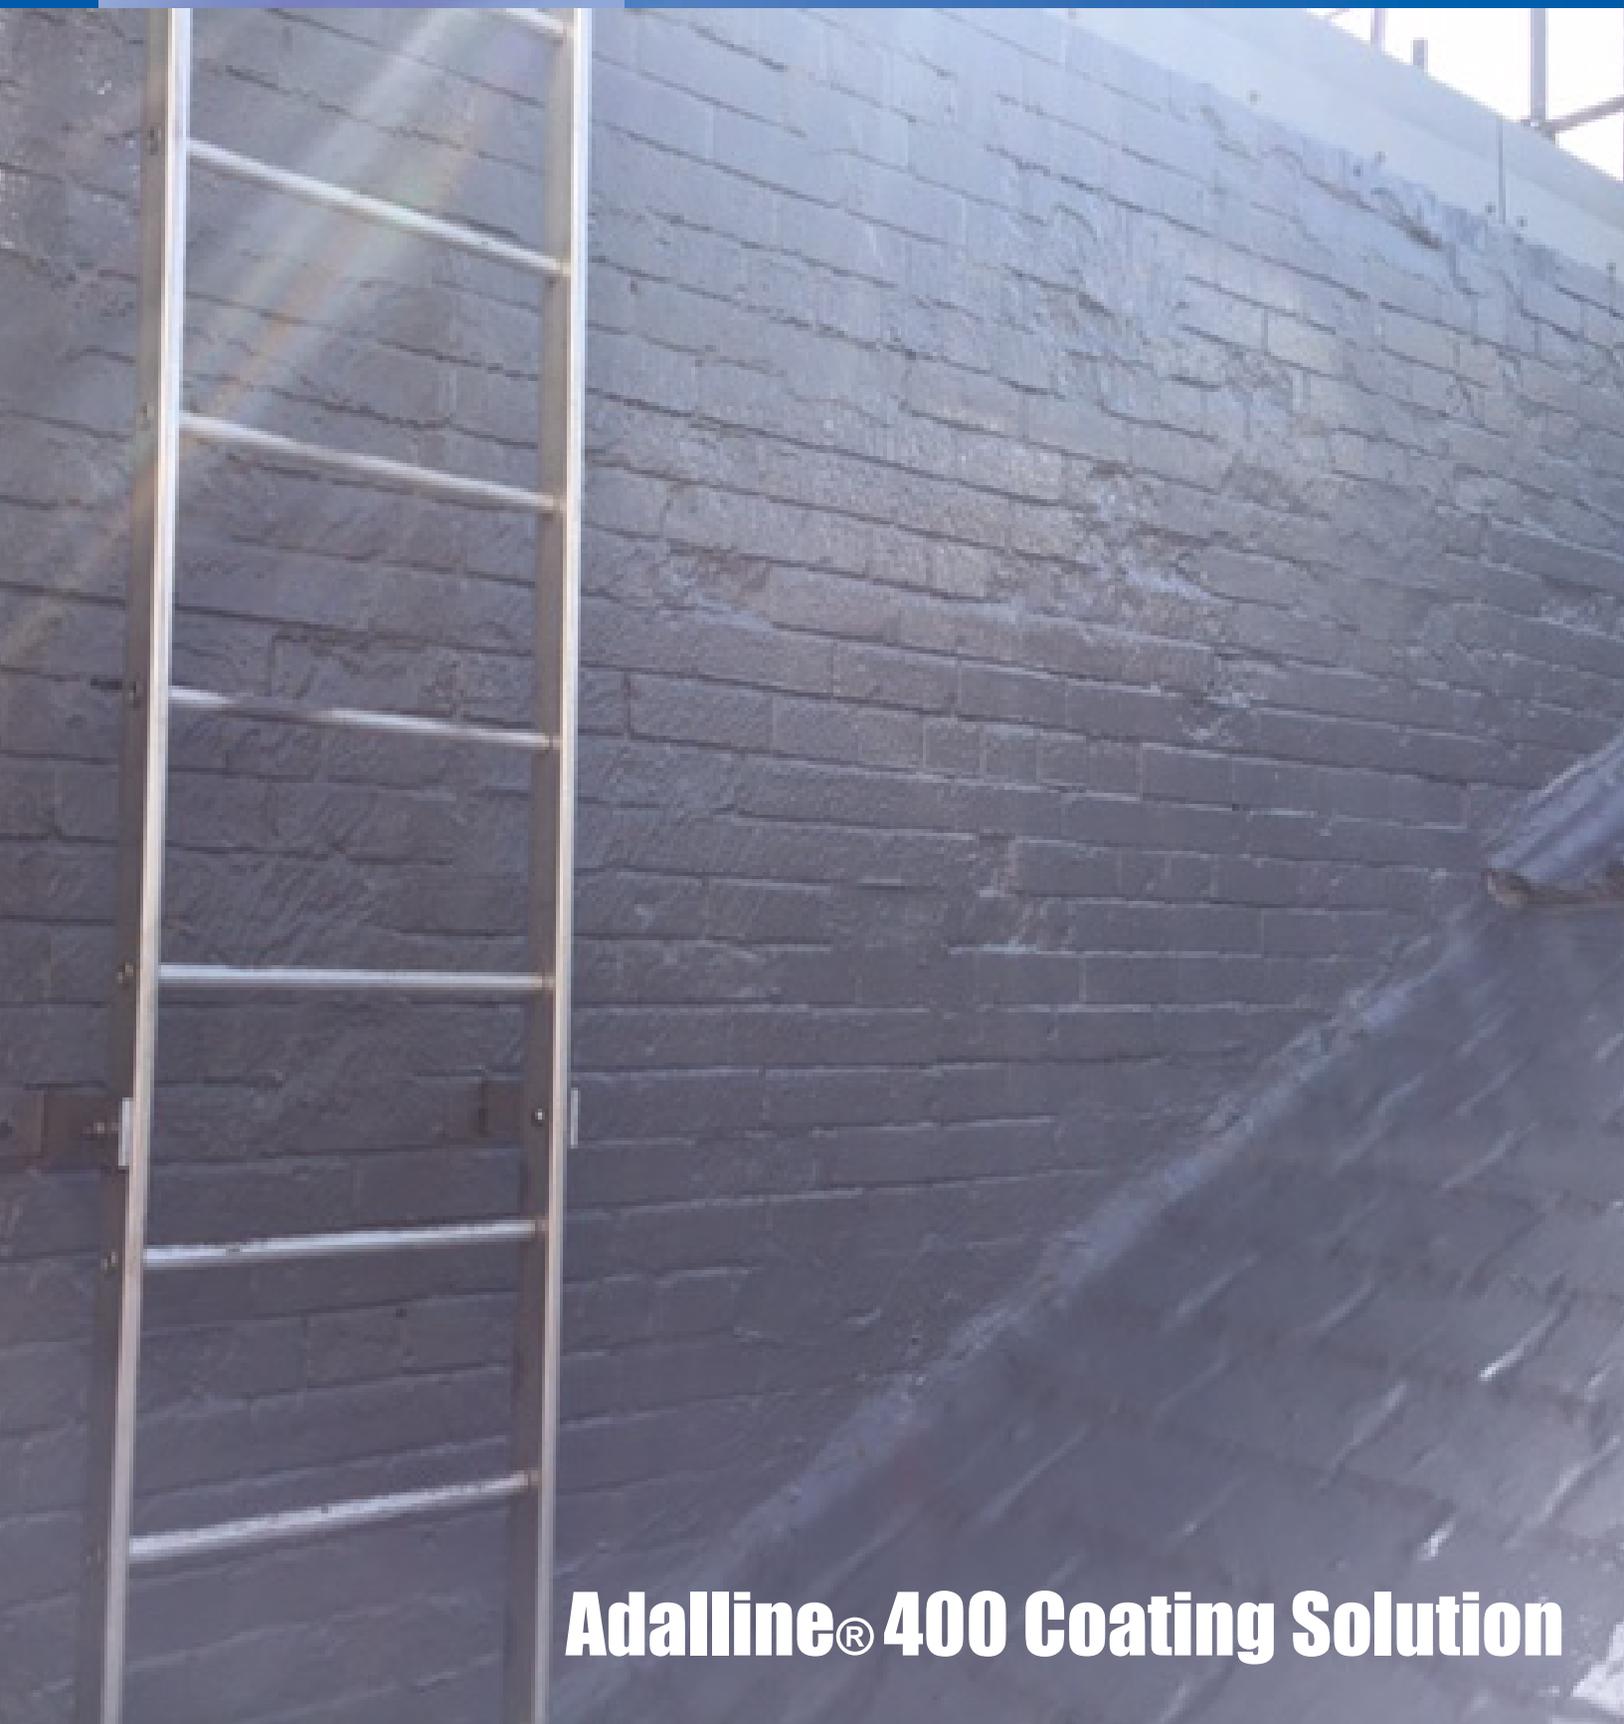
A large pitched roof on a BT cabling manufacturing site at Blackley, Manchester required urgent patch repairs. Some lead flashing was missing on the internal gable and general disrepair had resulted in water tracking through the roof on to water sensitive equipment below.

The Adler & Allan team carried out an initial wash down of the roof, removing vegetation and cleaning the surface. The defective lead flashing was removed, and gaps and cracks on the surface of the roof sealed with Rallithane 810, and elastomeric sealant. Stainguard rapide primer was then hand applied. Finally, a 2 mm thick Adalline® 400 polyurea coating was then applied through our trailer spray rig system.

The roof was lined with our unique Adalline 400 polyurea coating, adding to the roof structural integrity whilst providing long lasting and durable protection. Adalline™ is a highly versatile lining which is suitable for practically any internal or external surface, and in this case encapsulated brickwork on the gable end wall, welsh slate tiles, and corrugated aluminium and steel sections. Finally, to stop any water tracking underneath the lining, and provide another level of protection, the open edges were finished off with Rallithane soft joint beading.
