Case Study Protective Internal Tank Lining

RAF Marham

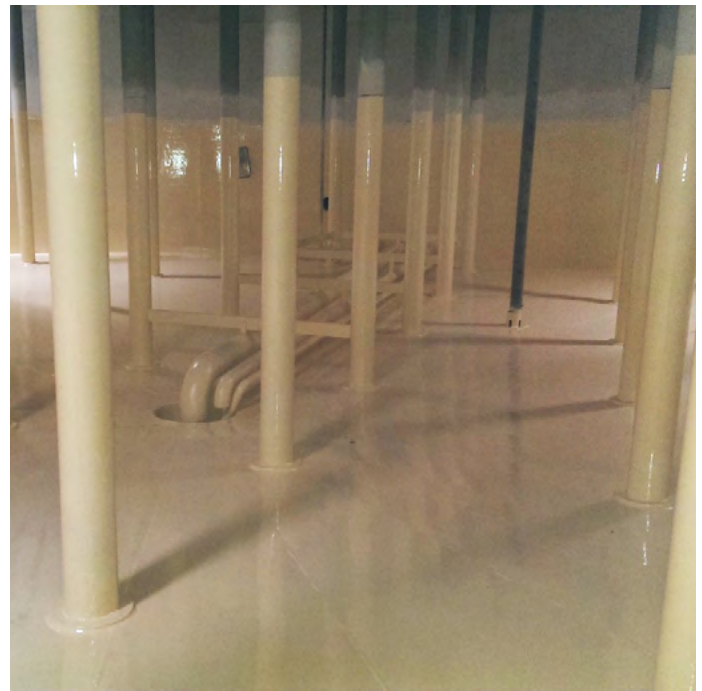
The tank and supporting columns were coated in Interline 984, a solvent-free, epoxy phenolic lining system. Applied in a single coat, Interline 984 offers chemical resistance to a wide range of applications. As this coating is resistant to crude, refined petrochemicals and biofuels, it is the ideal choice for use in storage tanks. The product is solvent-free, with low VOCs and complies with immersion testing requirements of E11350 for aviation fuel storage.

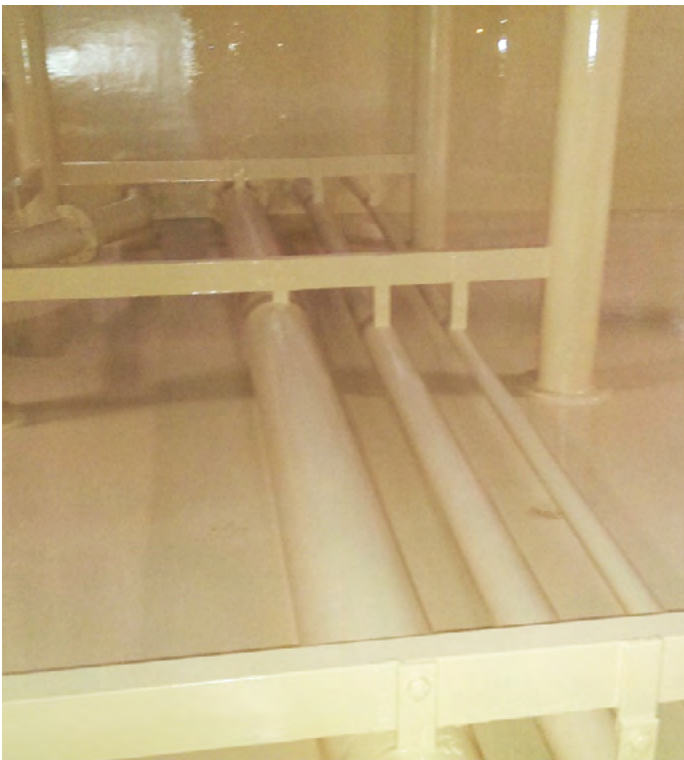
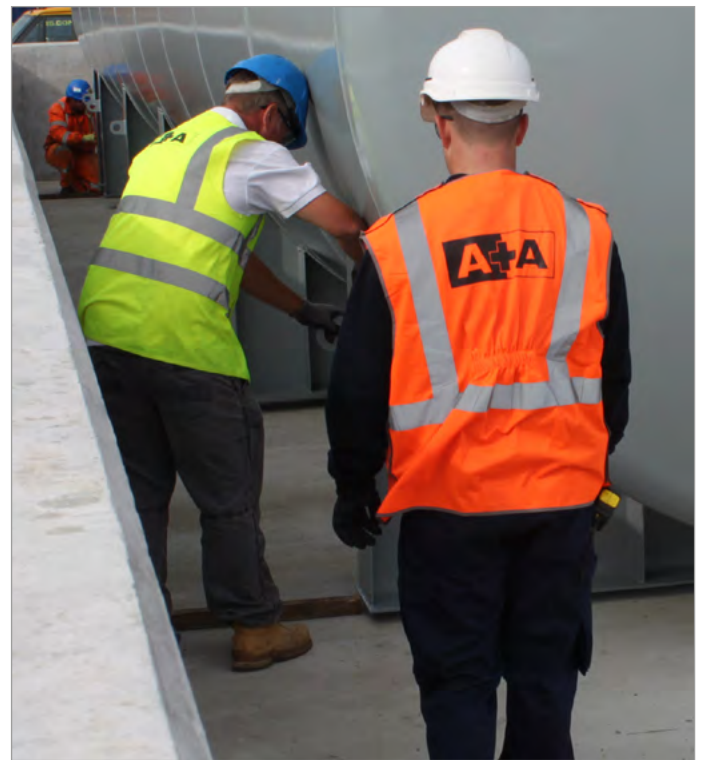
The project took six-weeks in total to complete, before and after the application of protective coating, the tank was cleaned thoroughly to ensure it was ready for use straight away.
